# TESTS OF ADSIL COATING

Test B - Long Term Test

FSEC-CR-1259-01

Principal Investigator  
Dr. Charles J. Cromer, P.E.

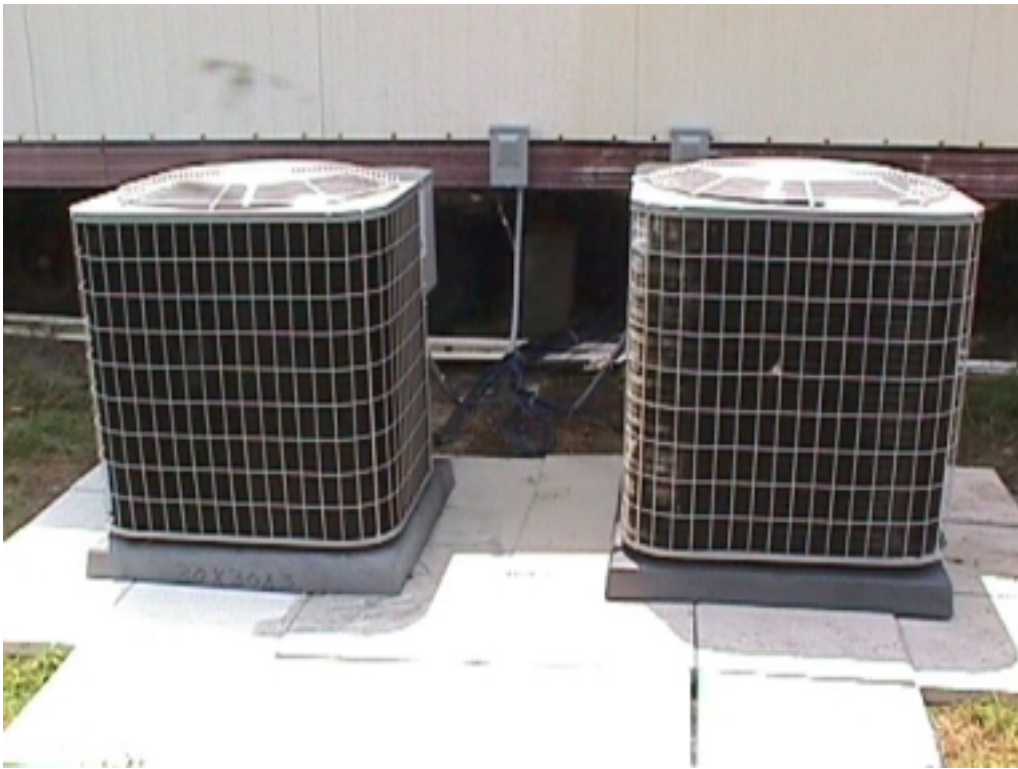
Figure 1. Installation of Two Carrier Condensers Side by Side for Test. Unit B1, the Adsil Unit Has Been Cleaned and Some of the Black Factory Coating Removed.

Figure 1 shows the two condensers installed side by side outside of the Appliance Laboratory. Figure 2 shows one of the units being treated with Adsil. Notice that the second unit was covered to prevent any Adsil over-spray from coating the second unit. Figure 3 shows the enclosures constructed around the condensers and the ducting constructed to provide uniform air to each condenser. Notice the tops of the condensers are open so the air from the condenser fans is drawn into the inlet duct and blown out the top of the condensers. Figure 4 shows the interior of the ducting to the condensers, part of the top of the duct has been folded back to illuminate the interior for the photo. The tanks used to hold the salt mixture and pump assembly for the two misting nozzles are visible to the left of the photo.

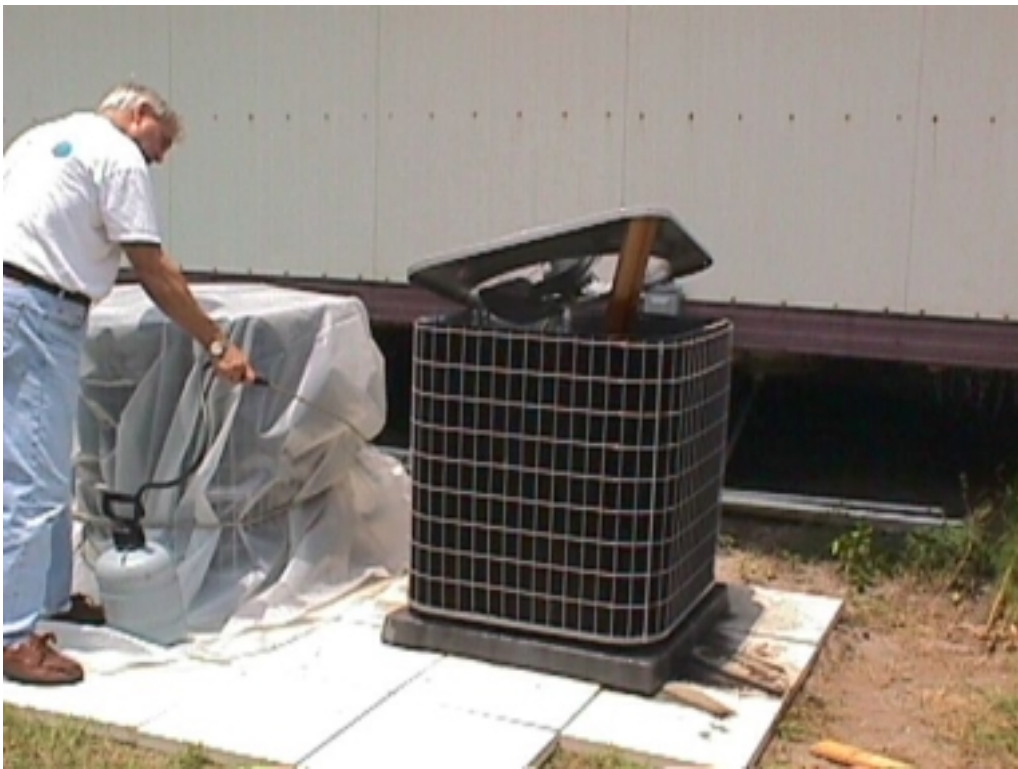
Figure 2. Adsil is Applied to Unit B1 Condenser.

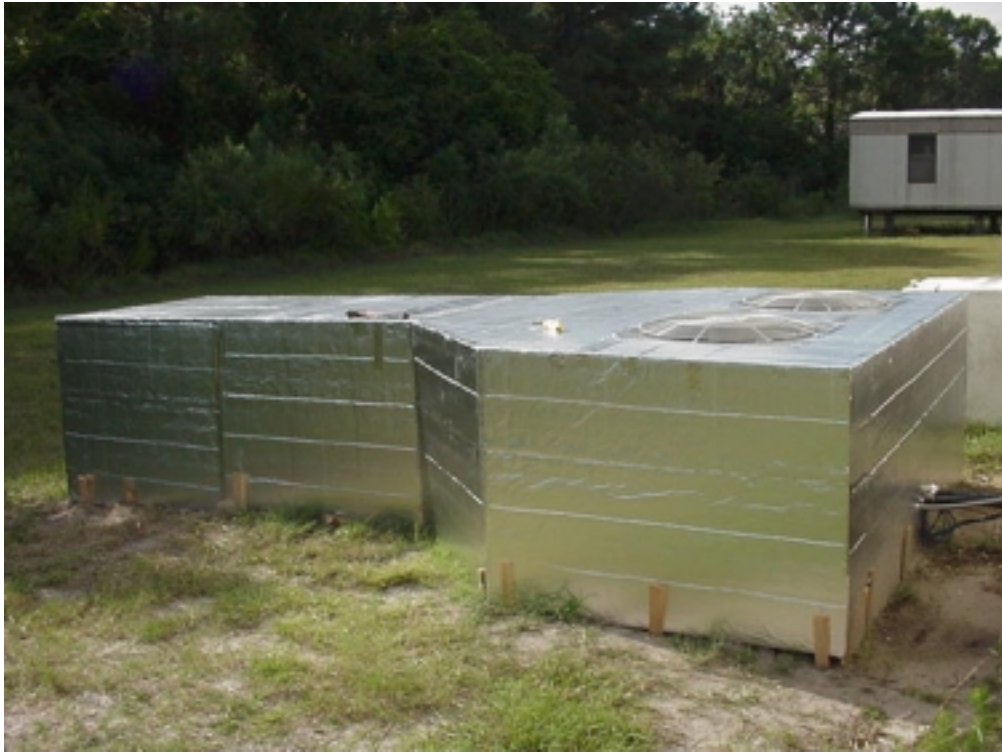
Figure 3. Ducting Constructed around Side by Side Condenser Units.

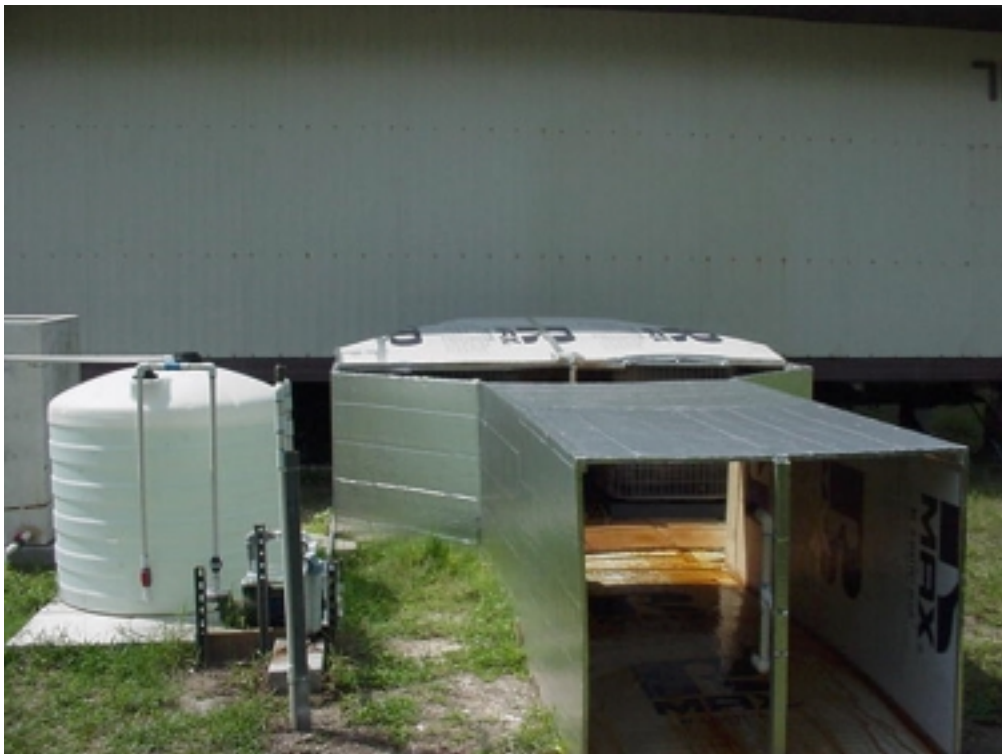
Figure 4. View Down Condenser Ducting and Salt Solution Holding Tank.

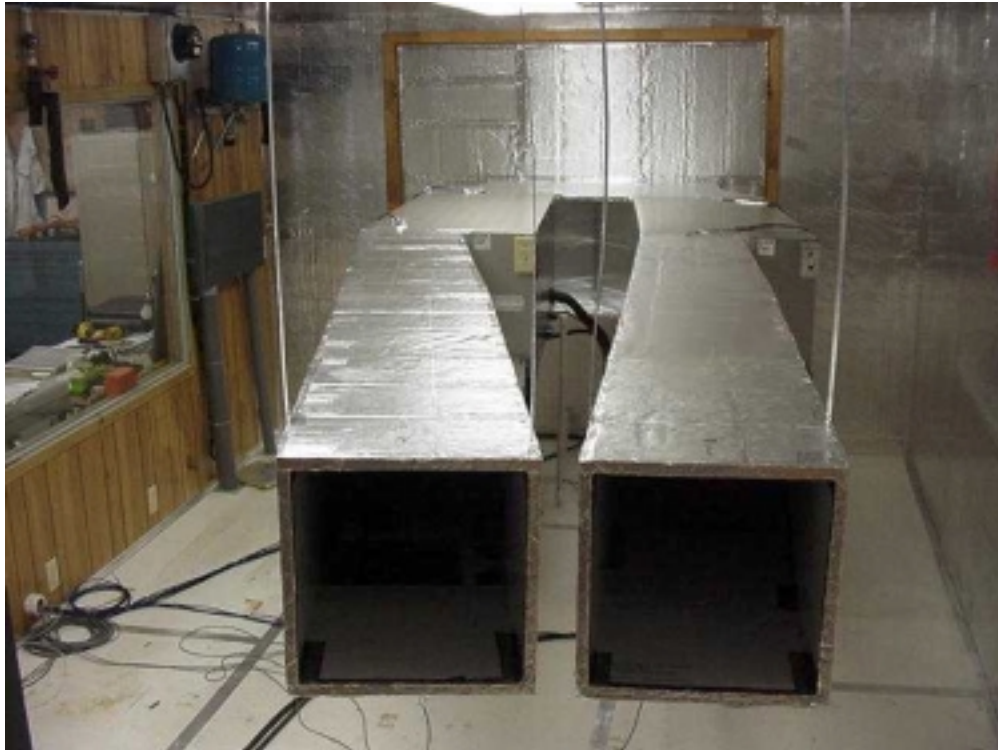
Figure 5. Side by Side Installation of Air Handlers within Appliance Laboratory.

Figure 5 shows the ducting constructed for this test that is located within the indoor environmental control chambers. This ducting provides for the air-enthalpy measurement of Btus delivered by both the air conditioner units. The instrumentation set up is the same as utilized during tests A1 through A5. Measurements are made on the temperature and RH of the inlet air, temperature and RH of the outlet air, and the air flow cfm so that Btus delivered by each AC coil are measured directly. During the same time intervals, the energy use of the AC units are measured by a pick up of pulses from standard Kwh meters. The electrical use is measured for both the air handler fan and condenser fan as well as the compressor. The EERs for the units are calculated for each test hour by dividing the total measured cooling Btu's (both latent and sensible) by the measured watts used during that hour.

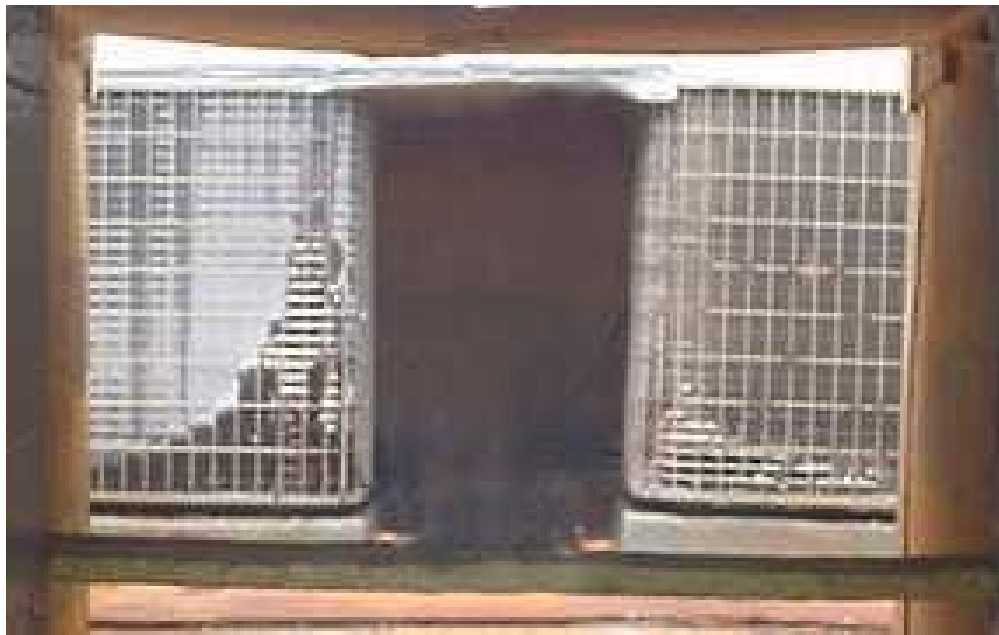
Figure 6. View from Air Inlet Duct of Two Condensers: Adsil on Right, Control on Left.

The two condenser units were installed new and operated under test from September, 11, 2000 through May 16, 2001 or 248 days. Both the condenser units experienced deterioration during the test. Figure 6 shows the two condenser units at the end of the test period as viewed from inside the duct providing air to the condensers. Though the assessment of visible deterioration is interpretive, it appears that approximately fifteen percent of the Adsil unit condenser area is corroded to the point of a significant reduction in heat exchange, while on the control condenser, approximately seventy-five percent of the fin area is similarly deteriorated. The Adsil unit corroded primarily at the area of heaviest input of the salt mist, where the control unit not only corroded more significantly in that area, but also experienced heavy corrosion in the bottom foot or so of the condenser around its entire parameter. Figure 7 shows a close-up view of the corroded area on the Adsil condenser at the end of the test, and Figure 8 shows a similar view of the untreated control compressor.

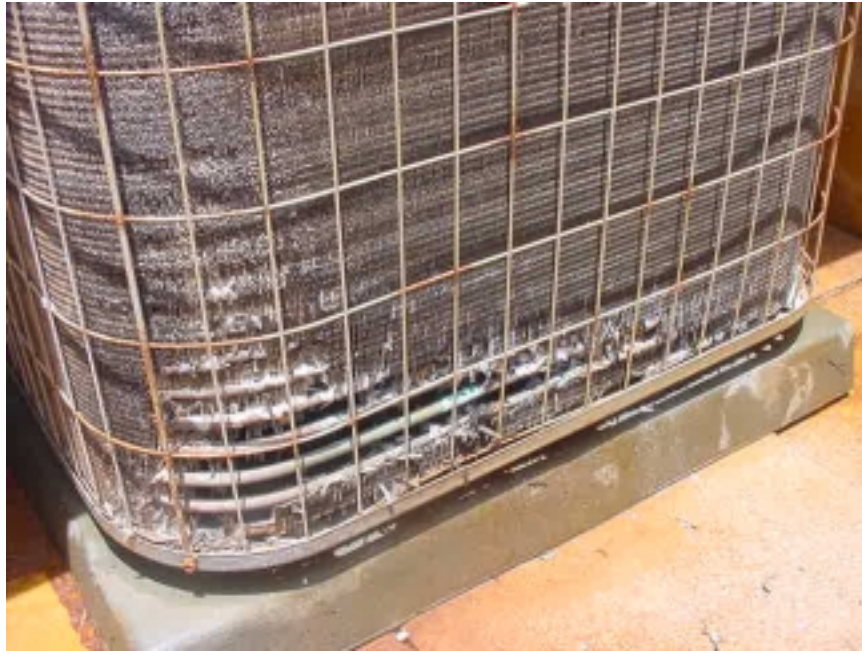
Figure 7. Deteriorated Area of Adsil Coated Condenser.

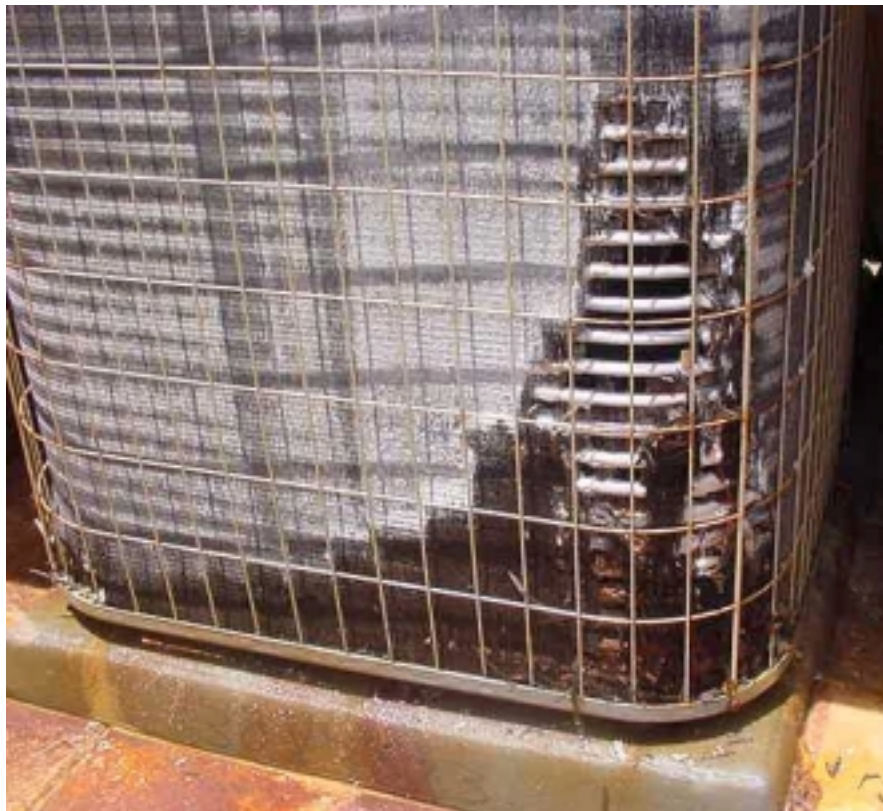
Figure 8. Portion of Deteriorated Area of Control Condenser.
