Energy Solutions

Residential Case Study

Location: Richmond, Virginia

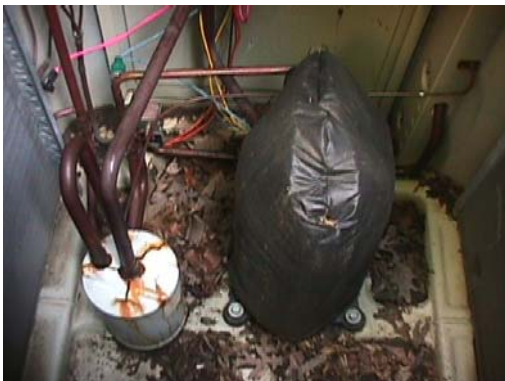
BEFORE SERVICING

Situation: A ten year old, 2-ton unit with moderate coil clogging, mildew and debris both in the coils as well as on the unit proper. Due to this clogging and corrosion a moderate loss of heating & cooling efficiency and possible accelerated deterioration by excess debris and other corrosion-causing agents was noted. Before servicing the recorded output temperature at a primary upstairs residence duct was **53.5** degrees Fahrenheit. Various other temperature measurements were noted as follows: Condenser coolant line—**56.3** degrees F; Condenser fan output—**83.2** degrees F.

Solution: On May 10th 2002 Adsil AD-35 was applied to the unit, coils, and fins after a thorough unit cleaning and rinsing. As noted above, temperature measurements were taken at various cooling system locations before and after our servicing and application of AD-35.

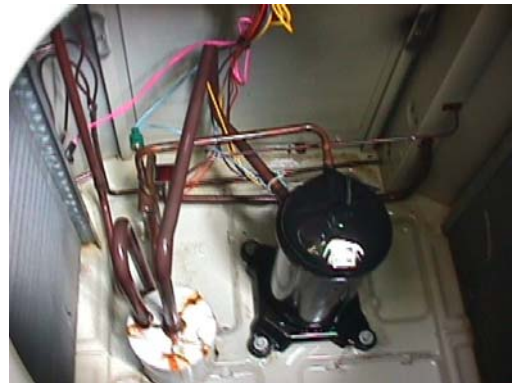
AFTER SERVICING

Results: The result of our servicing and treatment program was a **5.4% reduction in output temperature** (i.e., *improvement* in unit heating & cooling efficiency) as compared with that at the identical residential location *before* servicing—reduced from **53.5** degrees initially to **50.6** degrees after servicing (additional measurements showed similar results: Condenser coolant line temperature dropped from 56.3 to 55.3; and the condenser output temperature increased from 83.2 to 87.0—an *increase* that was expected & appropriate and demonstrated the increased transfer efficiency of the cleaned and treated unit. Additionally, the cleaning and application of AD-30 restored the unit to a like-new condition in appearance, performance, and operation. To this day, six years later, the unit continues to operate at this improved efficiency level with corresponding energy and electricity cost savings.
