Residential Case Study

Residence

Location: Richmond, Virginia

BEFORE and ***AFTER*** Case Study

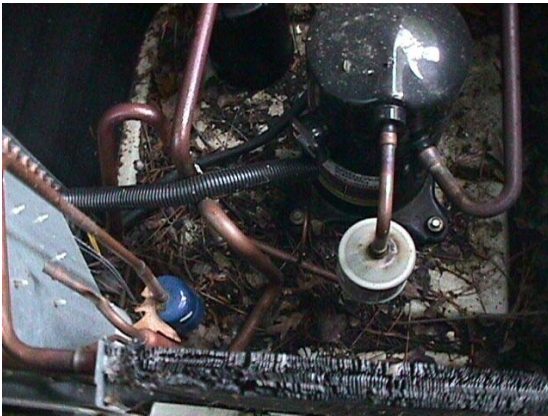
BEFORE SERVICING

Problem: A four year old, 2.5-ton unit with significant coil clogging, mildew and debris both in the coils as well as in the unit proper. Due to this clogging, a significant loss of heating & cooling efficiency and possible accelerated deterioration by excess debris and other corrosion-causing agents was noted. Before servicing the recorded output temperature at a primary residence inside heating/cooling duct was 48.5 degrees Fahrenheit.

Solution: On May 5th and 6th 2002 Adsil AD-30 was applied to the coils and fins after a thorough unit cleaning and rinsing. Internal duct air temperature measurements were taken before and after our servicing and application of AD-30.

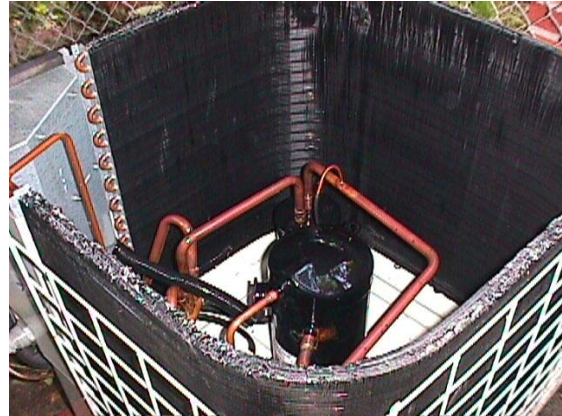
AFTER SERVICING

Results: The result of our servicing and treatment program was a **9.1% reduction in output temperature** (i.e., *improvement* in unit heating & cooling efficiency) as measured at the identical residential location before servicing—from 48.5 degrees initially to 44.2 degrees after servicing. Additionally, the cleaning and application of AD-30 restored the unit to a like-new condition in appearance, performance, and operation. These improved performance levels are still enjoyed six (6) years post application and the unit continues to operate flawlessly with no other mechanical servicing of any type.

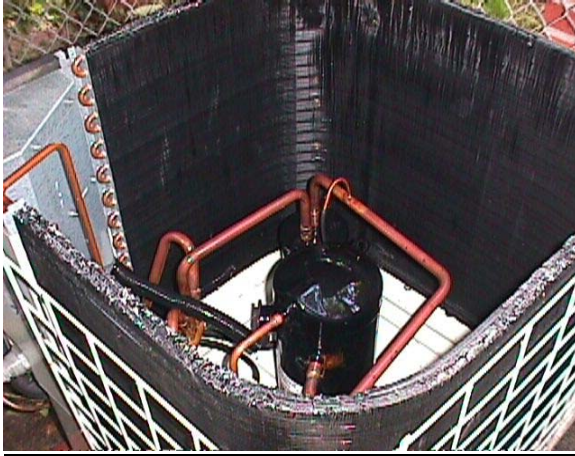
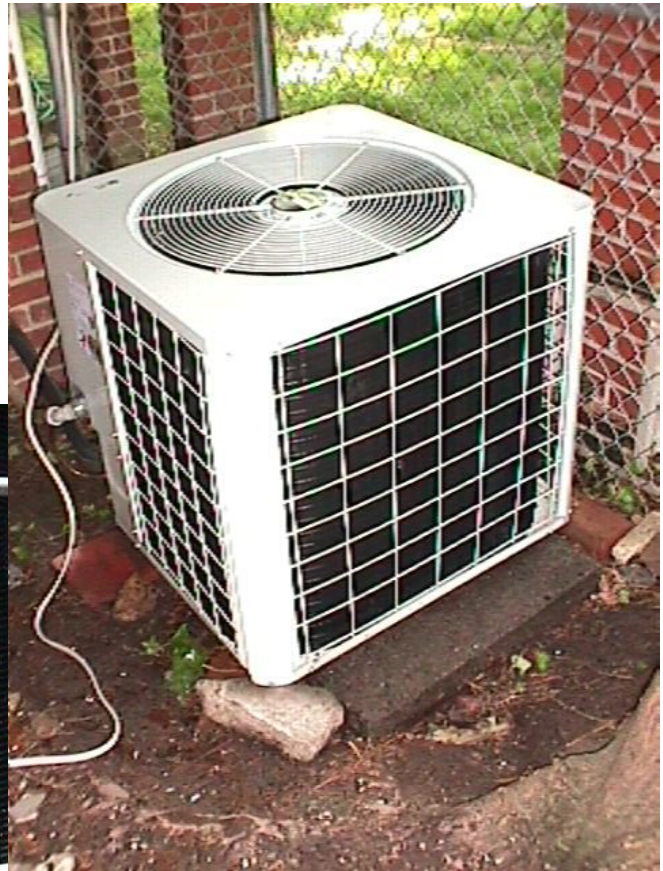
AFTER

Cleaned & Coated HEAT PUMP unit reduced energy consumption & associated electricity cost by 8% during summer cooling & winter heating. This unit continues to operate at this improved efficiency level six (6) years after initial cleaning & coating service by Energy Solutions
