Energy Solutions

CASE STUDY

Problem: Sulfur from waste processing corrodes copper and aluminum. HVAC units must be replaced every 3 to 4 months.

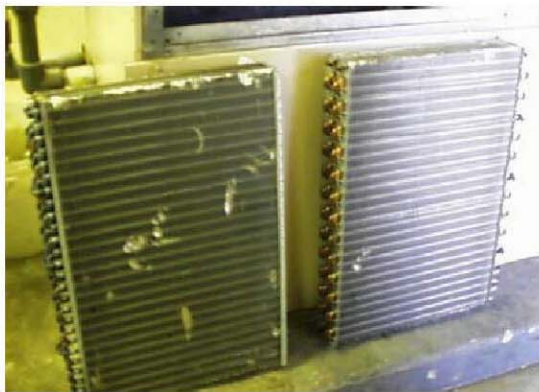
With AD30

Solution: AD30 applied to HVAC coils and fins prevented corrosion, extended the unit life and reduced maintenance cost. Pictures below show units coated and uncoated with AD30 left in the facility for 8 weeks. No noticeable sign of corrosion is on the AD30 coated unit.
